Research on Fall Prevention and Protection from Heights in Japan

Abstract: The high frequency of fall accidents is a serious problem in Japan. Thus, more stringent countermeasures for preventing falls from scaffolds were developed and incorporated into institutional guidelines. These countermeasures aim to decrease deaths caused by falls from scaffolds. Despite the improvements in such measures, however, the rate of accidental fall deaths remains high in Japan's construction industries. To improve the rigor of the countermeasures, a committee was established in our institute by the Japan Ministry of Health, Labour, and Welfare. This committee investigated the regulations applied in other countries and evaluated construction industry compliance with existing fall prevention guidelines. After considerable research and discussion, the Occupational Safety and Health Regulations and Guidelines were amended in 2009. The effects of the amended regulations have recently been investigated on the basis of accident reports. This paper describes the investigation and its results. The paper also discusses other research and workplace safety countermeasures for preventing falls and ensuring fal

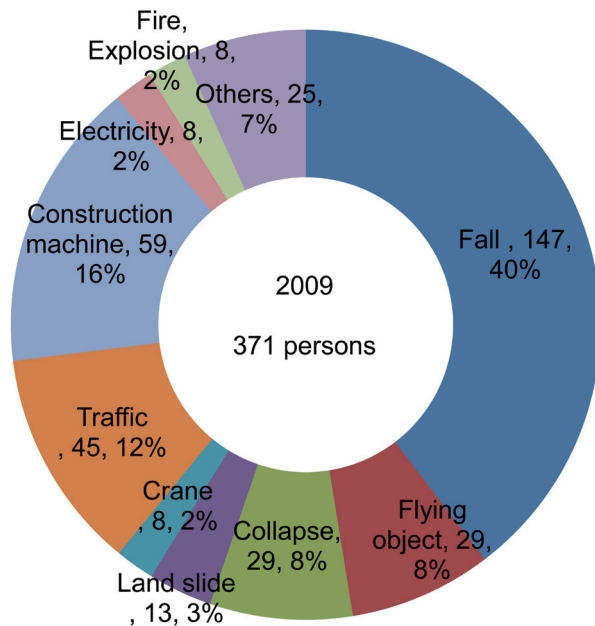
Figure 1 shows the number of accidental deaths in the Japanese construction industry in 2009. As previously

Fig. 1. Number of accidental deaths in the Japanese construction industry in 2009.

stated, approximately 40% of fatal accidents during construction were caused by workers' falls from heights and some were caused by falls from scaffolds.

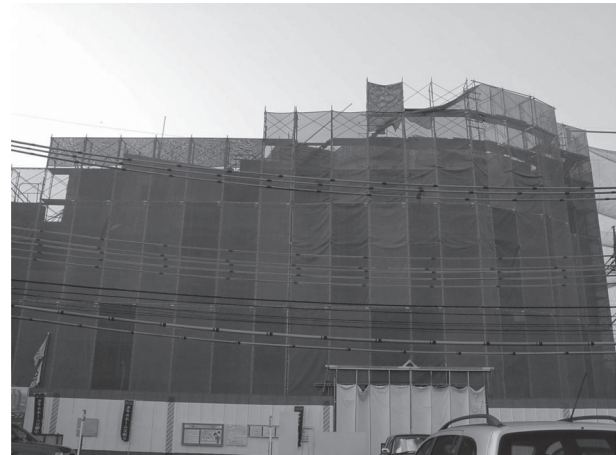
Fig. 2. Scaffolds covered with scaffold sheeting.

To develop additional preventive measures for scaffold-related falls, the MHLW established a committee at the JNIOHS. This committee is mandated to investigate the safety regulations applied in the construction industry in other countries and to evaluate various Japanese construction methods in accordance with current safety guidelines. The committee's work experimentally confirms the effectiveness of using scaffold sheeting as a covering around scaffolds in preventing falls. This method is extensively used in Japan, as shown in Fig. 2.

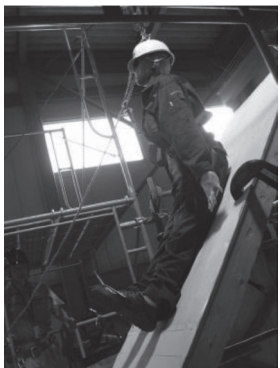
lated walking (Cases 1 and 4), tripping at the edge of a platform (Cases 2, 5, and 10), and sitting while at work (Cases 3, 6, and 11). An experiment was also carried out using a slide to confirm the strength of scaffold sheeting (Cases 7–9). For Case 8, deteriorated sheeting was used because scaffold sheeting is typically re-used in construction sites. In all the experiments, the dummy did not fall from the scaffold despite the postures and the deterioration of the sheeting, thus leading us to conclude that scaffold sheeting is an effective fall prevention measure²⁾.

Case	Posture	Type of scaffolds	Photos	Case	Posture	Type of scaffolds	Photos
1	Standing	Prefabricated

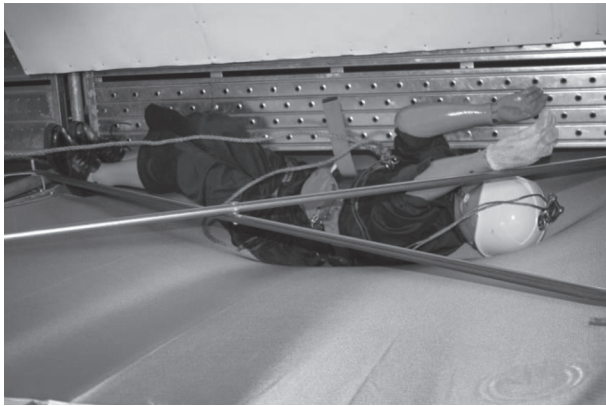
Nonetheless, occasional falls from the space between work platforms and scaffold sheeting continued to occur. Such incidents are attributed to space expansion stemming from the pressure exerted by workers' bodies (Fig. 4). When workers reach down to the sides of scaffolds to conduct work, they push the sheeting to make room for movement, thereby widening the space between the platform and the sheeting. Given this consideration, the committee regarded scaffold sheeting as an imperfect means of preventing falls from scaffolds. With reference to the regulations in other countries, the committee discussed and recommended the installation of mid-rails, lower bars, and other similar structures to prevent falls from the space between a guardrail and the work platform erected on scaffolds.

Fig. 4. This dummy almost fell from the space between the scaffold sheeting and the work platform.

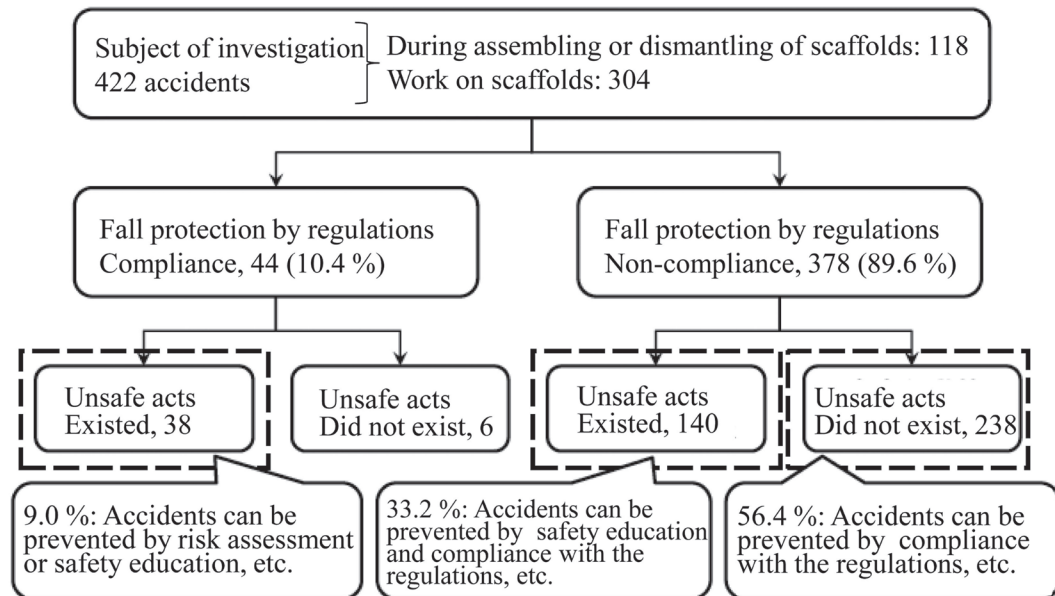
To determine other factors that contribute to falls from scaffolds, the injury accident reports were further analyzed. Figure 6 shows the classification of factors that caused fall accidents in 2011. Approximately 90% of the accidents (involving 378 persons) occurred in work environments characterized by illegal conditions. Most of these fall accidents could have been prevented through compliance with the amended regulations. Additionally, 42.2% of the accidents (involving 38+140=178 persons) occurred because of unsafe acts. In addition to compliance with the amended regulations, therefore, risk assessment and safety education are needed.

Fig. 6. Factors that contribute to fall accidents from scaffolds.

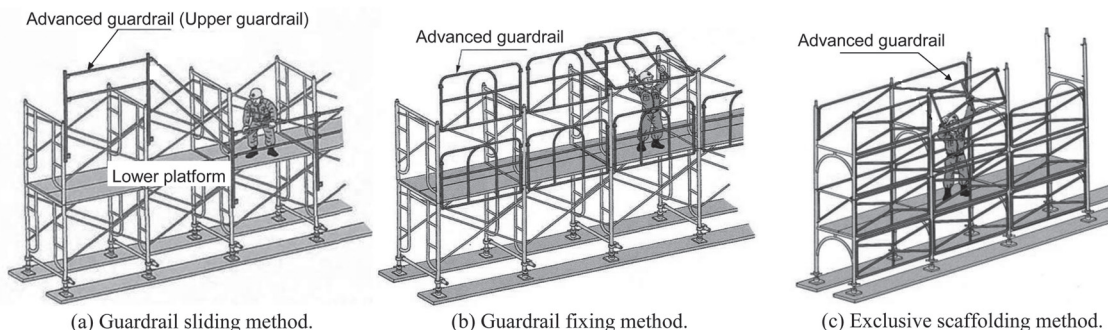
In Japan, the preceding guardrail installation method is occasionally used to prevent falls from scaffolds. The MHLW 2003 safety guidelines aimed to increase the adoption of this method, but these guidelines were amended in 2009 for the purpose of fostering enhanced safety in work environments. Figure 8 illustrates the installation method for a preceding guardrail. In this method, upper guardrails are always set from lower platforms using advanced guardrails, and workers are constantly protected from falls by the advanced guardrails at the top of a previously erected scaffold. The MHLW investigated the use rate of this method on 3,657 construction sites. Figure 9 shows the results. Approximately 34% of construction sites use this method³⁾, indicating moderate adoption.

Fig. 8. Preceding guardrail installation method.

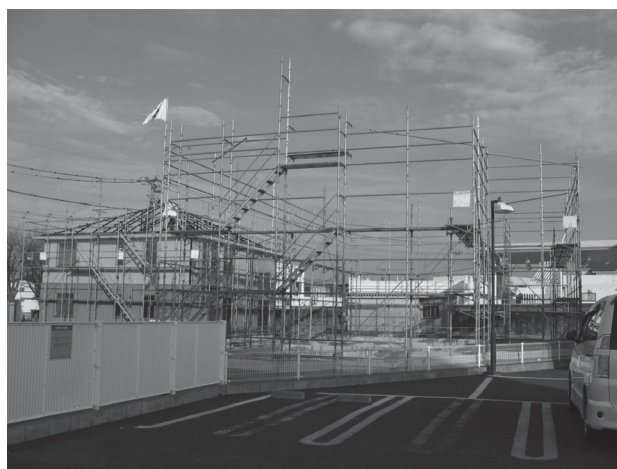
In Japan, the preceding scaffold construction method is typically used in house construction projects (Fig. 10). The MHLW 1996 safety guidelines aimed to encourage the use of this method, but these guidelines were amended in 2006, also to ensure improved safety in work environments.

Fig. 10. Scaffolds erected by the preceding scaffold construction method.

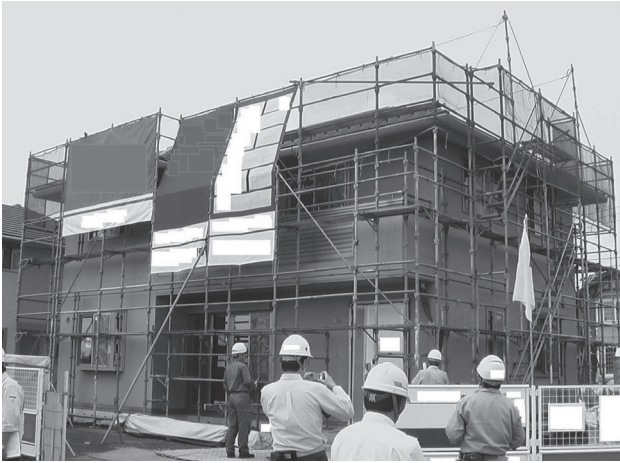
Figure 11 shows a house constructed by the aforementioned method, in which scaffolds are assembled before the frame of the house is erected and are used in all construction stages to prevent falls by guardrails. This method is extensively adopted in housing construction sites; as a result, fatal fall accidents in such areas decreased by more than 75% between 1996 and 2005⁴⁾.

Fig. 11. A house constructed by the preceding scaffold construction method.

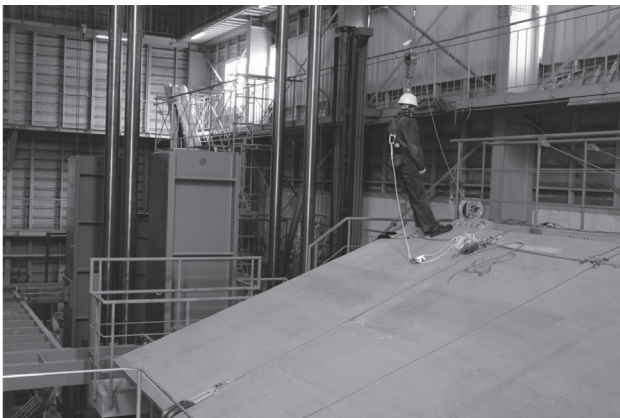
Figure 12 shows a JNIOOSH test conducted on falls from a roof. This test was performed to confirm the effects of fall protection via rope access on a roof for short-term works, such as minor roof repair works and installation of TV antennas.

Fig. 12. Fall test from the roof at the JNIOOSH.

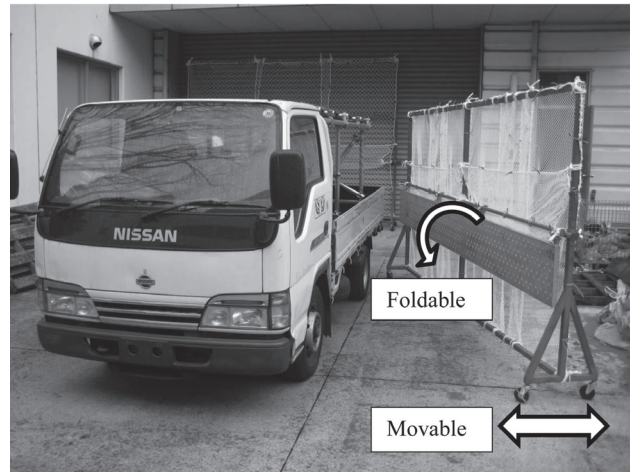
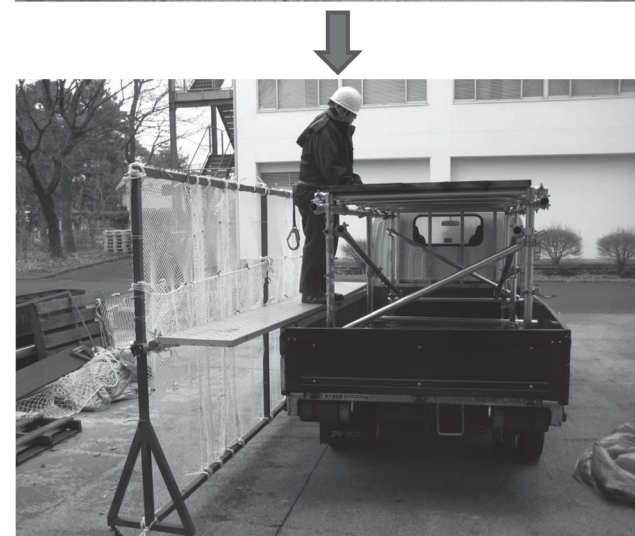
Fig. 13. Work stage developed by the JNIOOSH for preventing falls during cargo-handling operations.

Figure 13 shows a work stage developed by the JNIOOSH to prevent falls during cargo-handling operations. The work stage is designed to facilitate the use of narrow work spaces. For this purpose, the work stage was converted into a movable and foldable structure.
