# EXPERIMENTAL EVIDENCE ON WEAR BEHAVIOURS OF FLOOR SURFACES AND AN APPLICATION FOR SLIP AND FALL SAFETY ASSESSMENTS

In-Ju Kim and Anas Alduhishy

Department of Physical Therapy, College of Applied Medical Sciences  
University of Dammam, Dammam 31451, Kingdom of Saudi Arabia

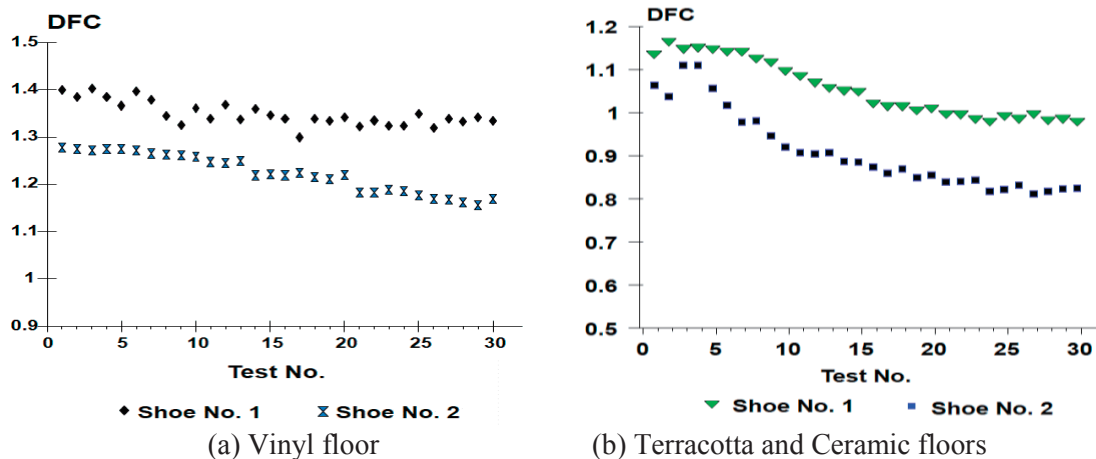
Fig. 1 shows the result of dynamic friction tests between the three floor specimens and two shoes. Quantities of dynamic friction coefficient (DFC) were largely decreased after the tests. In the case of the Polyurethane shoe (Shoe No. 2), the DFC values showed larger changes than the Nitrile Rubber one (Shoe No. 1) rubbed against all the three floors.

**Figure 1. Results of dynamic friction tests amongst three floor specimens and two shoes under clean and dry surface conditions: (a) Vinyl floor and (b) Terracotta and Ceramic**

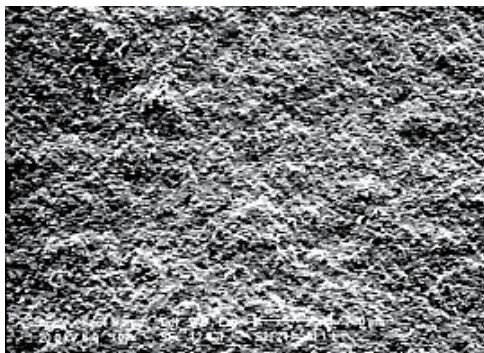
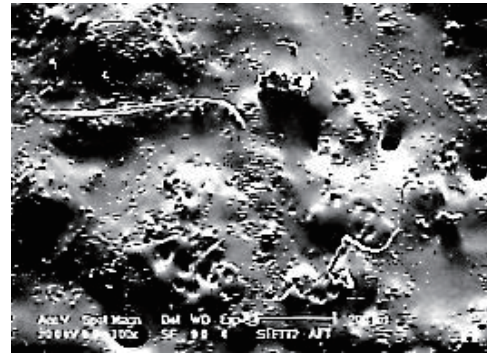
(a) Vinyl floor – BFT

(b) Vinyl floor vs. Shoe No. 1

(c) Vinyl floor vs. Shoe No. 2

(d) Terracotta – BFT

(e) Terracotta floor vs. Shoe No 1

(f) Ceramic floor – BFT

(g) Ceramic floor vs. Shoe No. 2

**Figure 2. Micrographs of the floor surfaces rubbed against two different shoes – BFT and AFT**

Fig. 8 shows examples of micrographs of the floor surfaces rubbed against the two shoes after the tests. Each floor experienced extensive wear events during the tests. A range of wear particles and debris with different patterns, shapes and sizes were found on the floor surfaces.

Those findings provided visible evidences of the flooring wear as a function of direct material transfer. The greater the roughness of the floor surface the wider the ranges and shapes of wear particles. The main findings on wear modes of the floor surfaces are summarized in the following:

- (1) Large amount of wear debris and particles were observed on the surfaces of wear tracks, depending upon the topographies of floor surfaces;
- (2) Different shapes, sizes, and types of wear debris were embedded into the valley areas of the floor surfaces;
- (3) Wear evolutions were generally associated with the nominal contact areas between the floor surfaces and the shoe heels; and
- (4) Irregular shaped fragments were commonly found in the wedge areas, but the transferred wear particles did not heavily cover the peak asperities of the floor surfaces.
