# EXPERIMENTAL STUDY ON FUNDAMENTAL PERFORMANCE OF SAFETY BELTS FOR FALL PREVENTION

Yasumichi HINO<sup>1</sup>, Hiroki TAKAHASHI<sup>1</sup> and Katsutoshi OHDO<sup>1</sup>

<sup>1</sup>National Institute of Occupational Safety and Health, 1-4-6 Umezono, Kiyose, Tokyo 204-0024, Japan

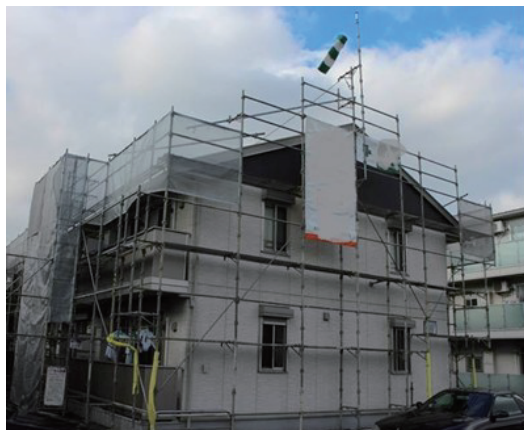
**Figure1. Fundamental safety measures following the housing works**

In Japan, most fall prevention countermeasures aim to ensure the stability and upright posture of workers while working different types of work surfaces. These countermeasures are established in Japan in clause 1 of article 518 and 519 of the occupational safety and health regulation. Figure 1 shows an example of the principal countermeasures applied during repair work on a residential house.

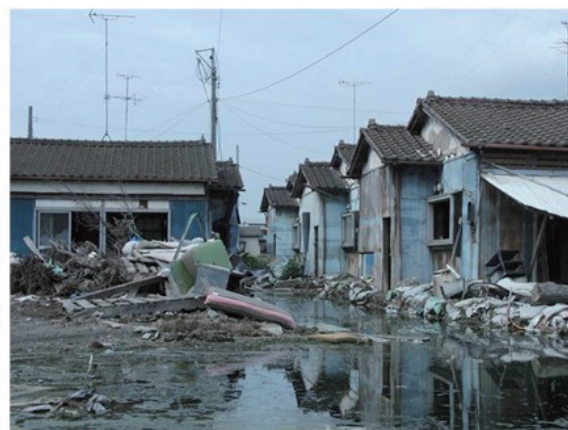
**Figure2. A disaster sites East Japan Earthquake**

place in the construction industry, as shown in Figure 3 (Ministry of Labor Safety and Health Japan, 2012). In the disaster relief works following the East Japan Earthquake and the major tsunami happened in march 2011, there was a high rate of falling accidents. Figure 2 shows one of the repair or dismantle work sites in the Tohoku region damaged by the natural disaster. It is quite difficult to carry out the required countermeasures in such a construction site. Establishing fall prevention measures for such sites is one of the most urgent tasks (National Institute of Occupational safety and Health, 2011).

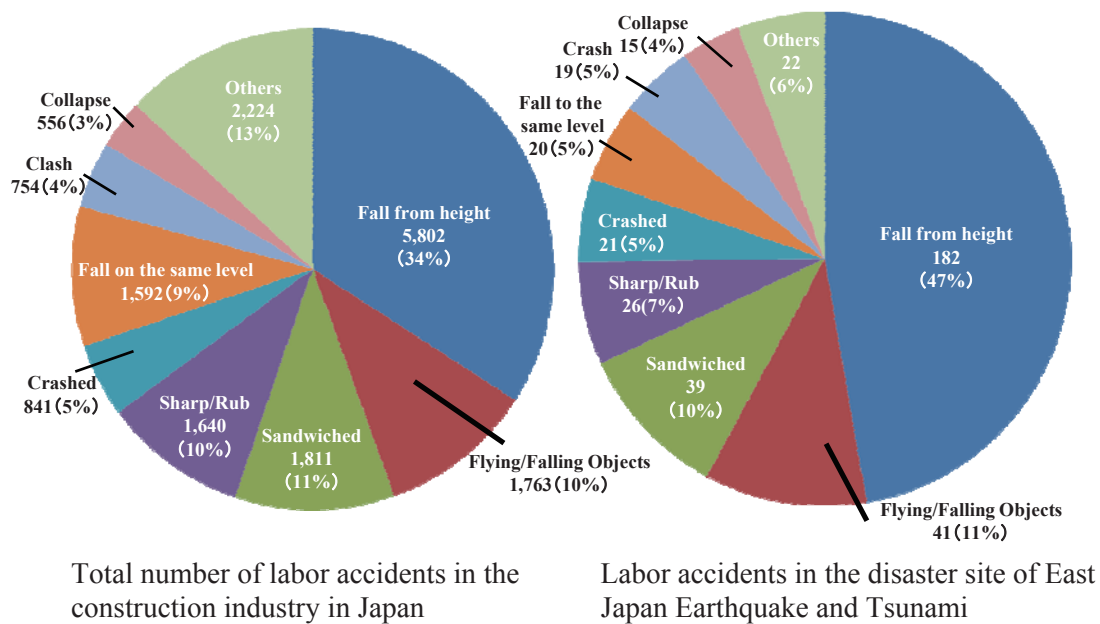
**Figure 3. Labor accidents in the construction industry in 2011**

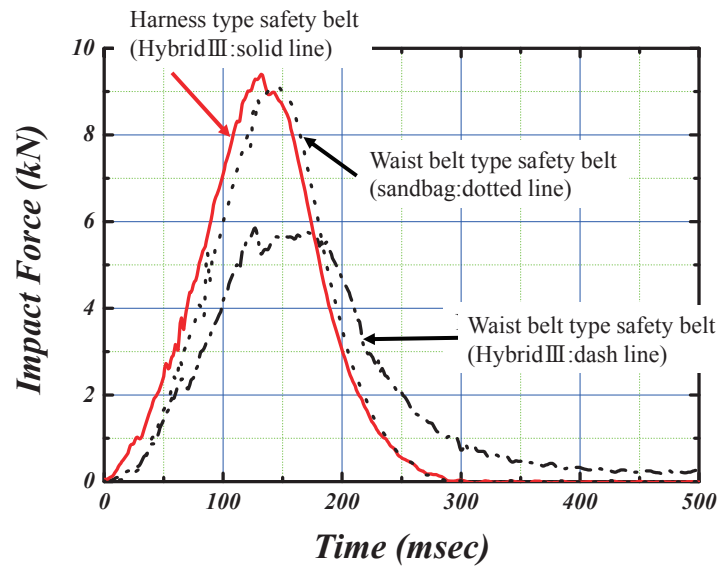
Figure 6 shows the time histories of the impact force acting on the safety rope of each type of safety belts. The impact force on the harness-type was similar to the impact force on the sandbag. The duration was also similar. In contrast, the impact force on the waist-belt-type safety belt was smallest in all the experiments. Thus, the duration is longer than other type experiments.

Figure 6. Impact force on the lanyard due to fall

From these results, the harness-type safety belt cannot be expected to reduce the impact force and energy during falls. However, the risk of serious head injury could be expected to be relatively low, because the falling posture was quite stable when the human dummy wore the harness-type. In addition, excessive bending of the waist would be low. With the waist-belt-type safety belt, the risks of serious head injury and body part injuries due to excessive bending would be very high, because the falling posture might be a handstand posture and the worker's head may crash directly into some construction equipment or the rigid grand surface.

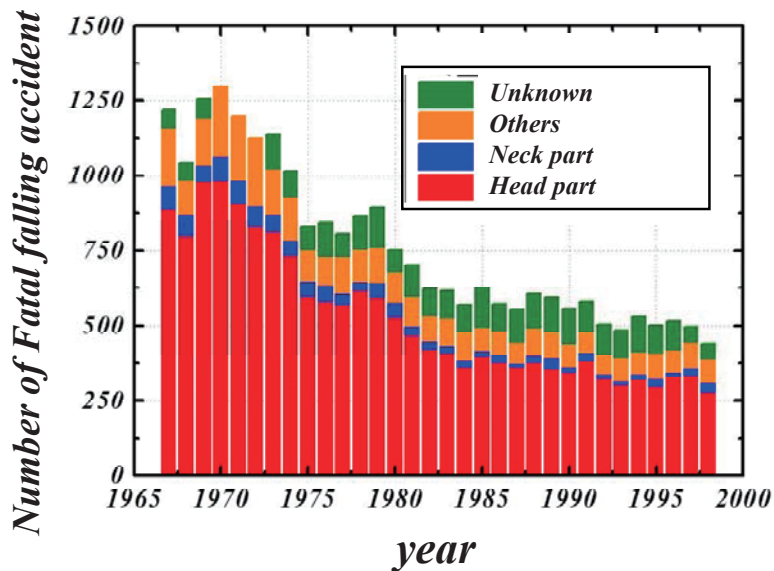
Figure 7 shows labor accident statistics data on the main parts injured in victims of fatal falls during 30 years in Japan. This figure shows that head injuries account for most of the damage during falls. Therefore, it is important to reduce the risk of head injury for prevention of fatal accidents and physical impediments.

Figure 7. Number of fatal falls divided into main injury region
