ACCIDENTS BY FALLS IN THE CONSTRUCTION INDUSTRY AND COUNTERMEASURES IN JAPAN

Yasuo Toyosawa, Katsutoshi Ohdo, Yasumichi Hino and Hiroki Takahashi

*National Institute of Occupational Safety and Health, 1-4-6 Umezono, Kiyose,
Tokyo 204-0024, Japan*

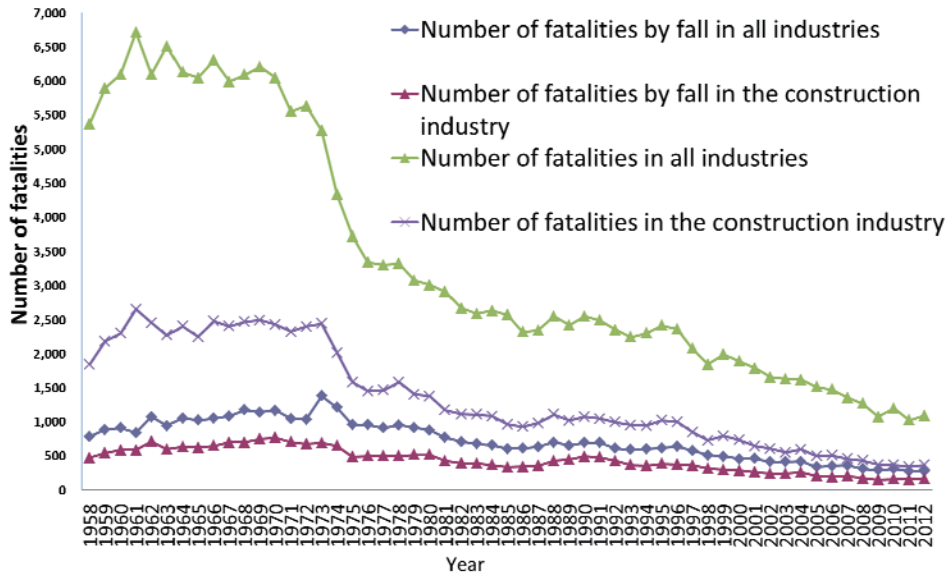
Figure 1. Trends in the number of fatalities in Japan (1958–2012)

There are many occupational accidents by falls in Japan (Figure 1). Among the occupational accidents in the construction industry, the ratio of the number of fall-related accidents to the number of all accidents resulting in casualties (absent from work for more than four days) is approximately 35%, and the ratio of the number of accidents causing fatalities is as high as approximately 43% (Figure 2). The prevention of occupational accidents by falls in the construction industry is a top priority in Japan. To establish effective countermeasures against accidents caused by falls, it is first necessary to analyse the accident data. In this paper, some countermeasures are discussed based on the results of such an analysis.

There has been a long-term decline in the number of casualties due to occupational accidents from a peak of 1.72 million in 1968. However, 544,862 workers (number of new recipients of workmen's compensation insurance in 2012) are still victims of occupational accidents and injuries every year. The number of fatalities in the construction industry peaked at 6,712 in 1961 and has gradually declined since this peak. The number nearly halved in the four years from 1972 after the Industrial Safety and Health Law came into force. It has continued to decline steadily over time due to decreases in the amount of construction investment and the

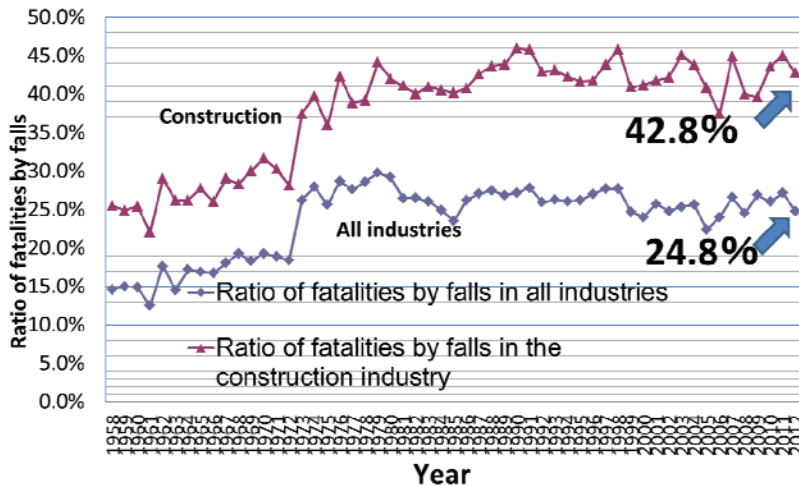
Figure 2. Trends in the ratio of fatalities by falls in Japan (1958–2012)

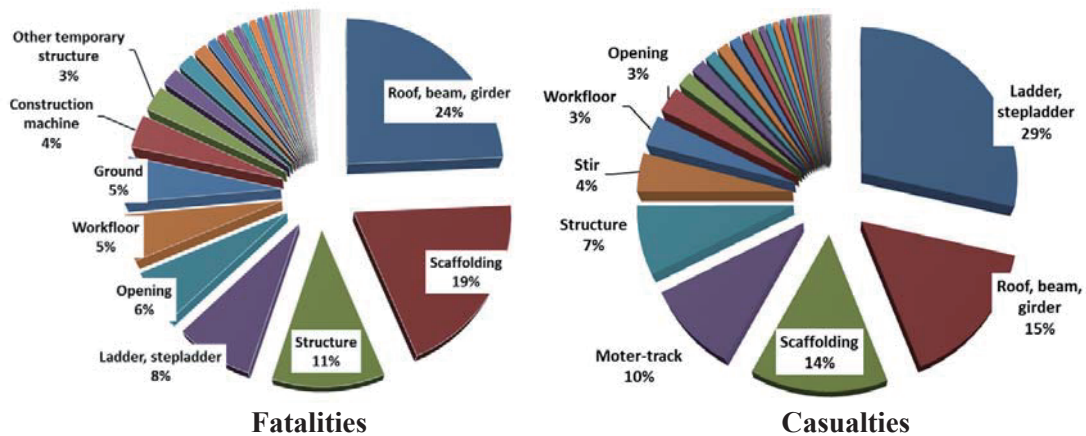
Figure 3. Places where falls occurred in the construction industry

Regarding the places where the accidents resulting in casualties occurred, sites of high-place work, such as “ladders and stepladders” ranked first, followed by “roofs, beams, girders” and “scaffoldings” in that order. Regarding places where fatal accidents occurred, “roofs, beams, and girders” ranked first, followed by “scaffoldings” and “building structures” in that order. (Figure 3) On the steel and reinforced concrete building construction sites, the fatalities were mainly due to falls from scaffolding and falls from building beams. As to the type of work, a large number of the accidents occurred during exterior finishing work, temporary work (particularly the erection and dismantling of scaffolds), and steel work. On the wooden building construction sites, roofs, beams, scaffolds, ladders, and stepladders were the main workplaces where the fatalities by falls occurred.

Figure 3 shows that 8% of fatalities and 29% of casualties due to falls from ladders and stepladders occurred in the construction industry. Further analysis revealed that wooden house building with ladders and stepladders accounted for one-third of all fatalities due to falls.

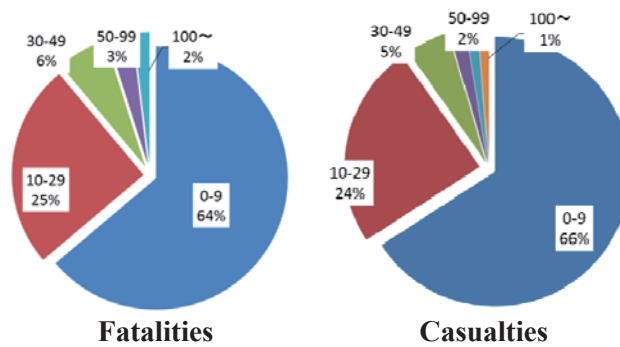
Figure 4. Number of employees in the company where falls occurred

Figure 4 shows the number of employees involved in the enterprises where the accidents due to falls occurred. About 65% of the accidents occurred in enterprises with fewer than nine employees. About 90% of the fatalities and casualties occurred in small-scale enterprises with fewer than 30 workers. Small-scale enterprises tended to have a greater number of fatalities and casualties than large-scale operations.
